Interoffice Memorandum

SUBJECT: **183-D WATER FILTER PLANT - FILTER BUILDING AND PUMP ROOM
STRUCTURAL INSPECTION**

A walk down was performed on May 03, 2012 to determine the structural adequacy of the 183-D Water Filter Plant – Filter Building and Pump Room. The primary purpose for the walk down was to determine worker safety for IH sampling. The area was assessed for the possibility of performing routine work to prepare the building for eventual Decontamination and Demolition. Attachment E details the results of the structural evaluation. Figure 1 shows the path taken to the electrical room during the walk down.

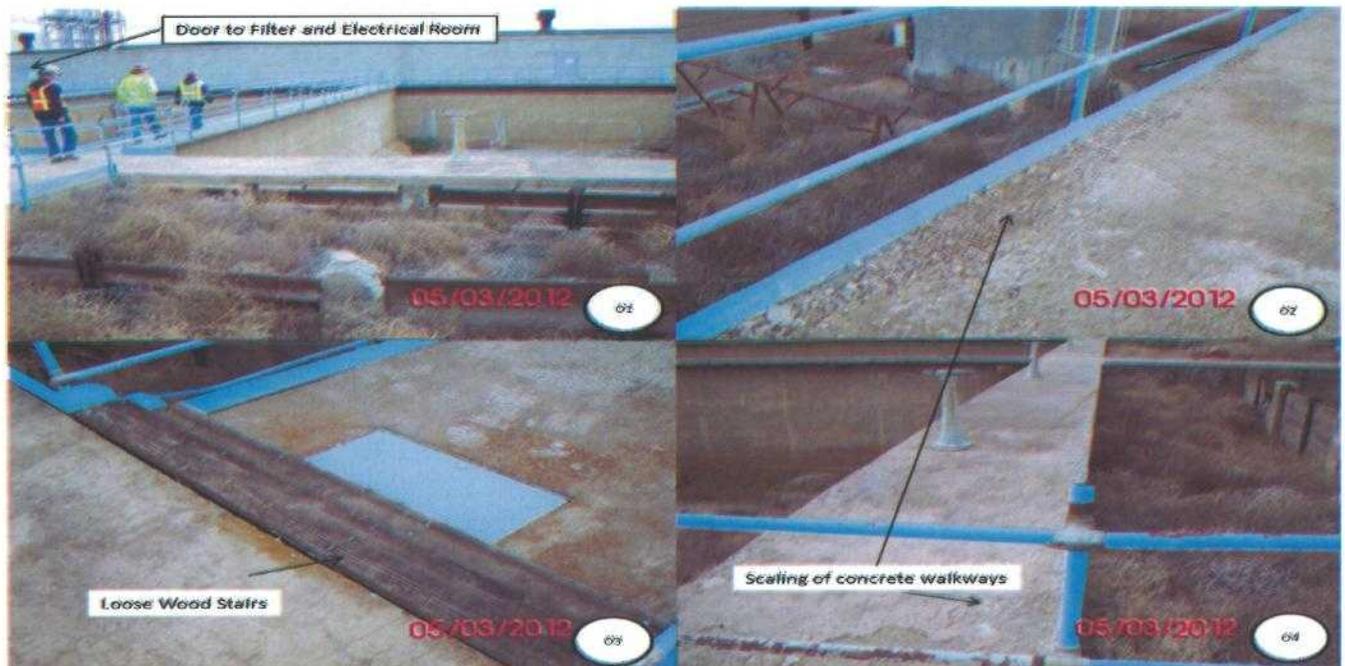
- **EXTERIOR STRUCTURE, PATHS AND WALKWAYS** – The walkways exhibit concrete scaling due to the being exposed to a corrosive environment. Some of the walkways exhibit concrete spall with exposed rebar. The rebar common to these areas exhibited moderate corrosion. There are some wooden stairs that were NOT secured properly that are tripping hazards.

Item 01 – Filter Building Masonry Wall with NO significant Structural Degradation

Item 02 – Scaling of Concrete Walkway

Item 03 – Loose Wooden Stairs

Item 04 – Scaling of Concrete Walkway

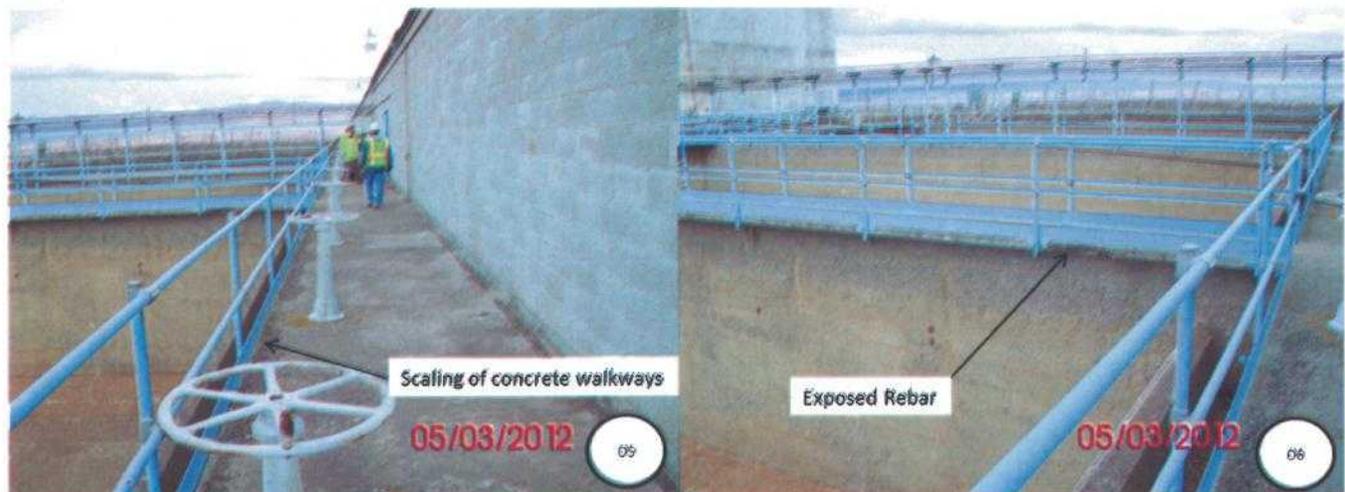
Item 05 – Scaling of concrete Walkways (Note that metal handrails do NOT exhibit structural degradation)

Item 06 – Concrete Spall on Walkway with exposed rebar

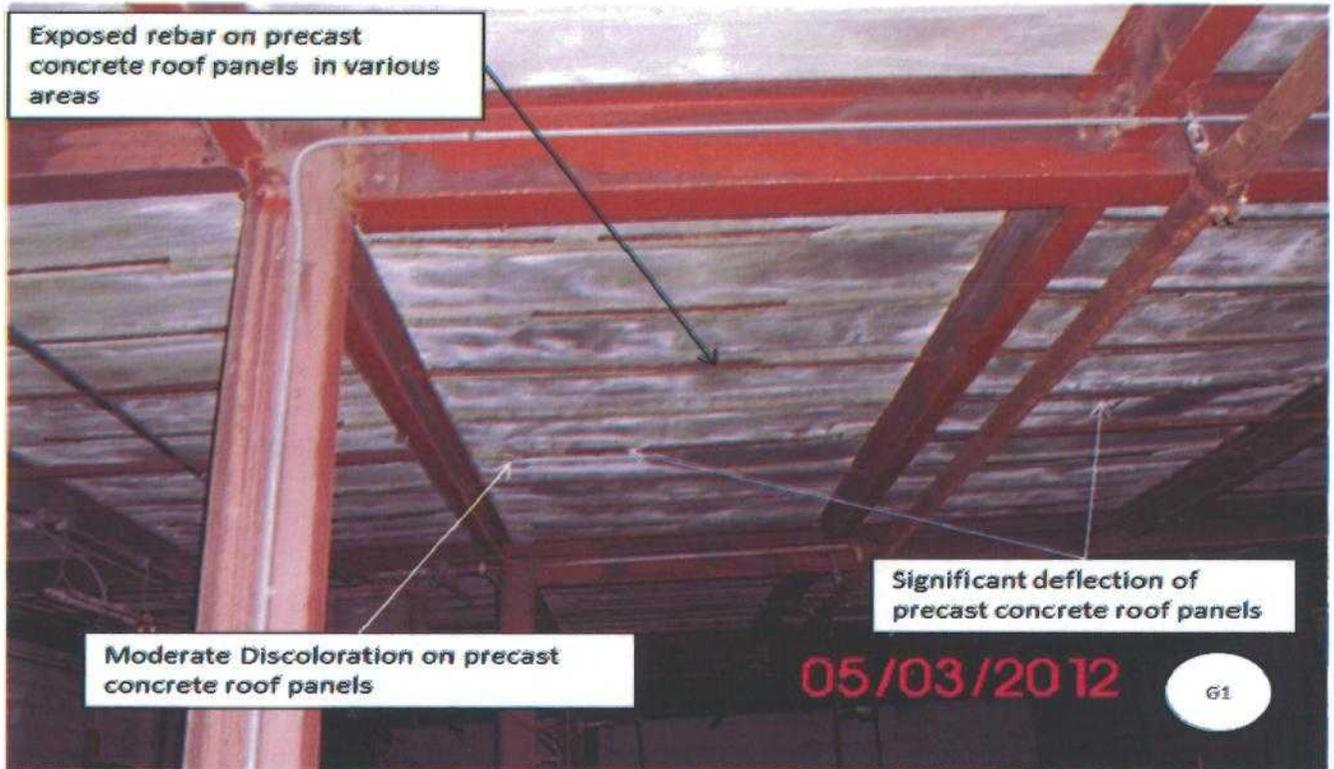
The pre-cast concrete roof panels exhibit severe degradation indicative of a structure that has been exposed to a corrosive environment. There is exposed rebar and significant deflections of the panels. In some cases, large pieces of the concrete panels have become detached and have fallen to the Filter Building floor. The panels also exhibited discoloration that is indicative of a potential chemical attack. These areas had “white stains” on their surfaces.

Based on my inspection, this area is not safe to perform intrusive work scope.

Item G1 – Significant structural degradation of concrete precast roof panels

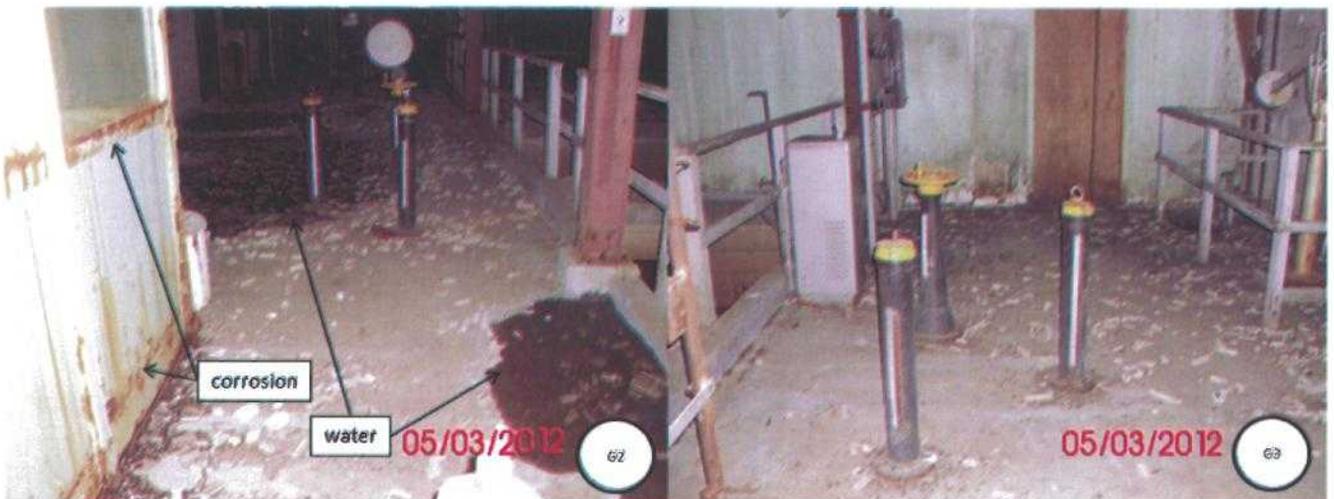
There were areas that had water pooled on the ground. The area common to these wet areas did NOT exhibit structural degradation.

There were also areas that exhibited biological waste. The area common to these hazard areas did NOT exhibit structural degradation.

Item G2 – Corrosion on metal wall panels and presence of water

Item G3 – Evidence of biological hazard

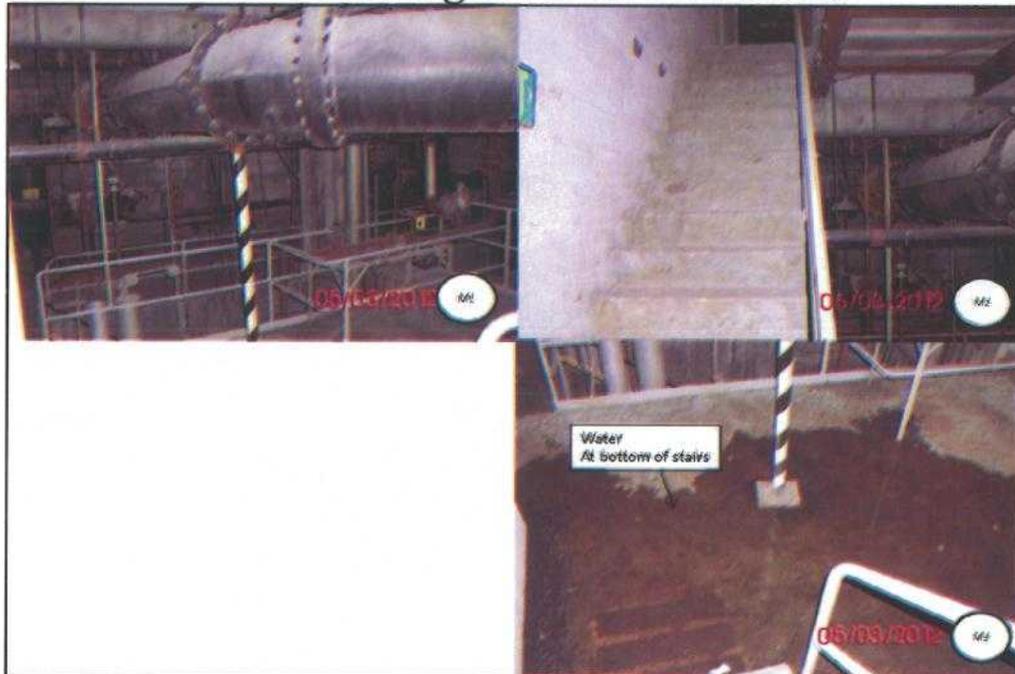
Item M1 – Structures and Components with NO significant Structural Degradation

Item M2 – Concrete Stair with NO significant Structural Degradation

Item M3 – Bottom of stairs with pooled water, NO significant Structural Degradation

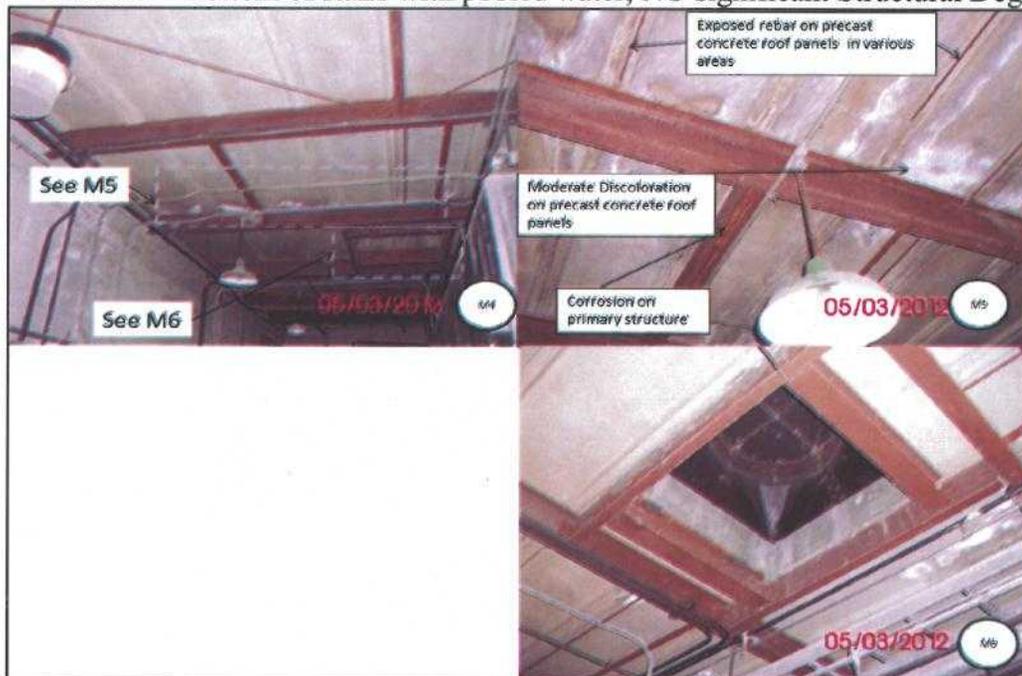
The pre-cast concrete roof panels exhibit severe degradation. The rebar of these panels were exposed to the environment. There were also panels which exhibited discoloration. These areas had “white stains” on its surface.

Based on my inspection, this area is not safe to perform intrusive work scope.

Item M4 – Roof area with minor discoloration, masonry walls have NO significant structural degradation

Item M5 – Metal Beams with moderate corrosion, exposed rebar, and discoloration

Item M6 – Penetration with NO significant structural degradation

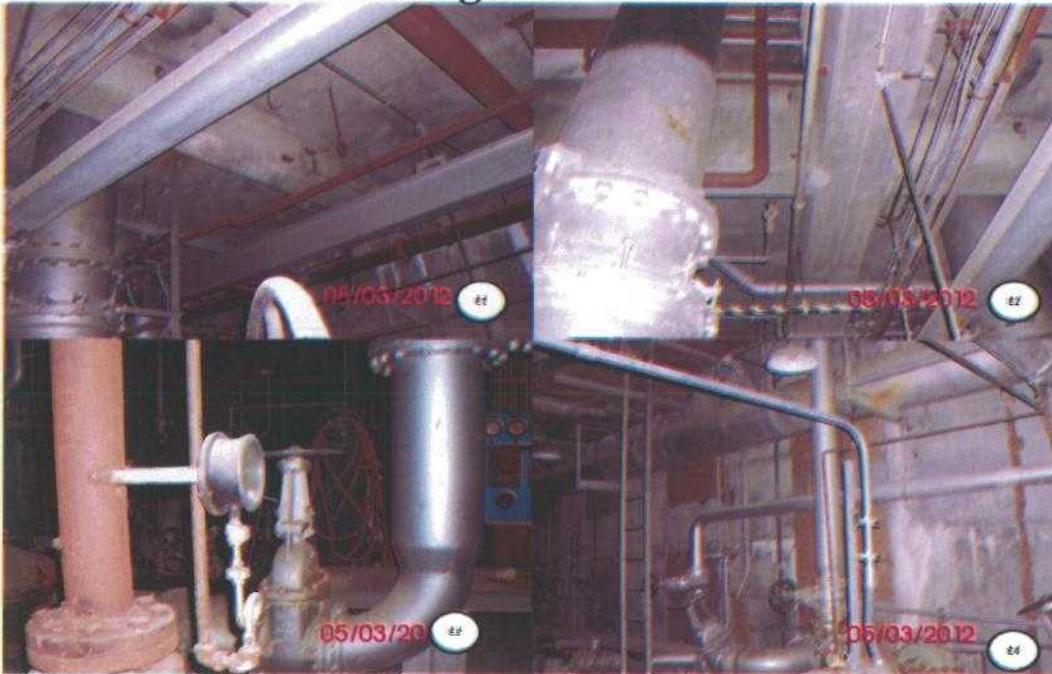
Note that picture E3 showed particulates in the air. The area should be assessed accordingly to ensure personnel safety.

- Item E1* – Concrete Roof with NO significant Structural Degradation
- Item E2* – Concrete Beam with NO significant Structural Degradation
- Item E3* – Structures and Components with NO significant Structural Degradation
- Item E4* – Walls with minor Discoloration

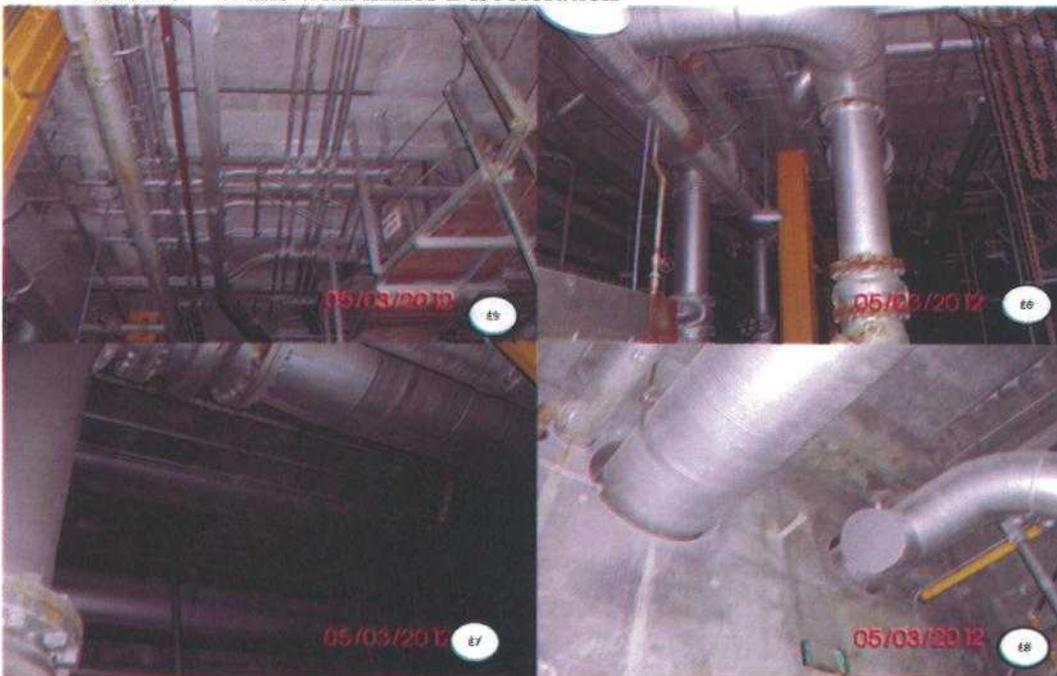
- Item E5* - Concrete Roof with NO significant Structural Degradation
- Item E6* – Structures and Components with NO significant Structural Degradation
- Item E7* – Concrete Roof with NO significant Structural Degradation
- Item E8* – Wall with Pipe Penetrations with NO significant Structural Degradation

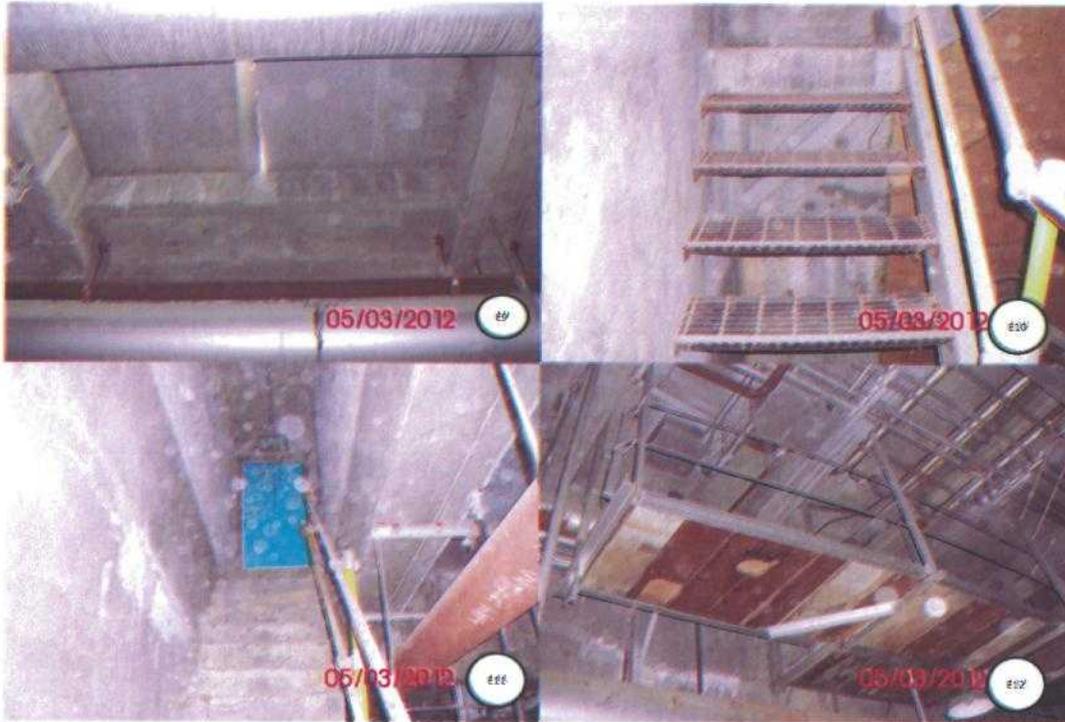
Item E9 - Concrete Roof Penetration with NO significant Structural Degradation

Item E10 - Metal Stairs NO significant Structural Degradation

Item E11 - Concrete Stairs and Entry Way with NO significant Structural Degradation (Note: Particulates in room)

Item E12 - Balcony with NO significant Structural Degradation
